## Investigation report

Report into the death of an underground mine worker,  
James Hern, at the CSA Mine, Cobar NSW on  
11 June 2014

Report prepared by the NSW Mine Safety  
Investigation Unit

June 2015

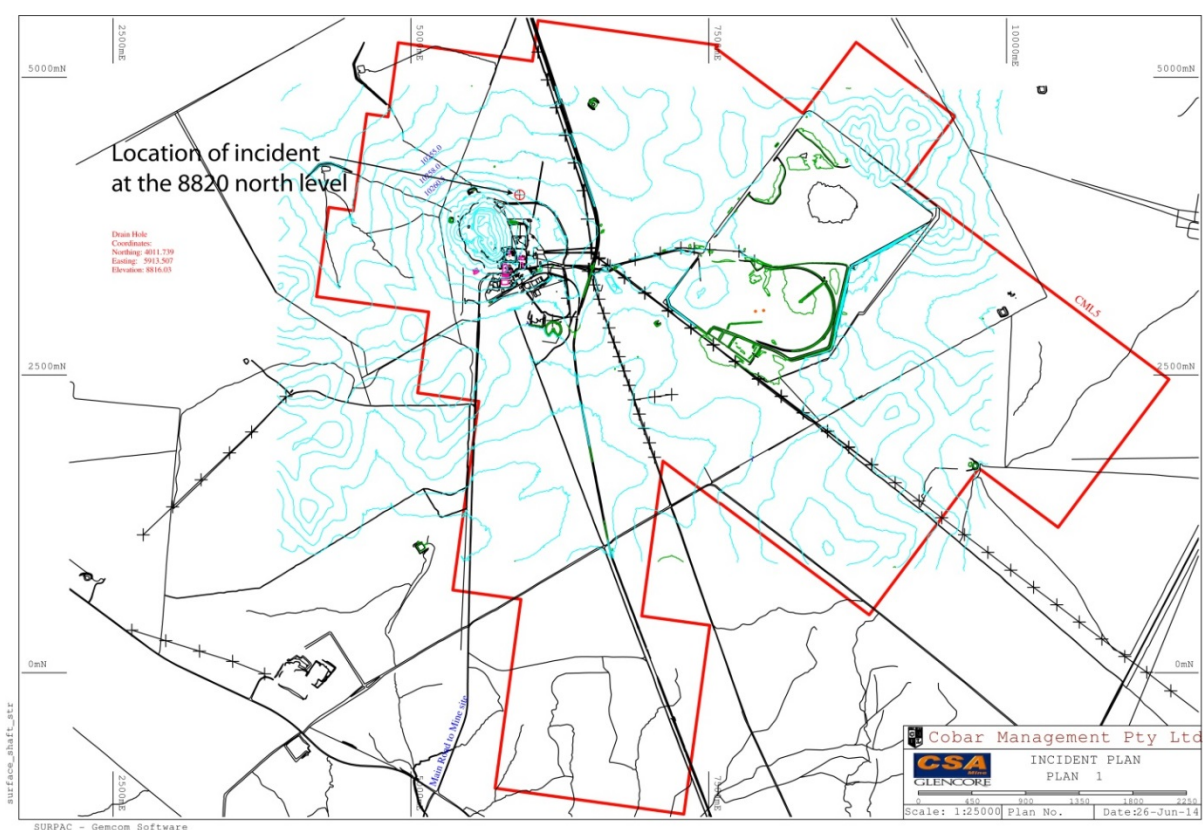
**Figure 1 Incident plan 1 shows the incident scene at 8820 north level sump relative to CML5 note the red text in the upper left hand quadrant depicts the actual coordinates of the drain hole at the incident scene.**

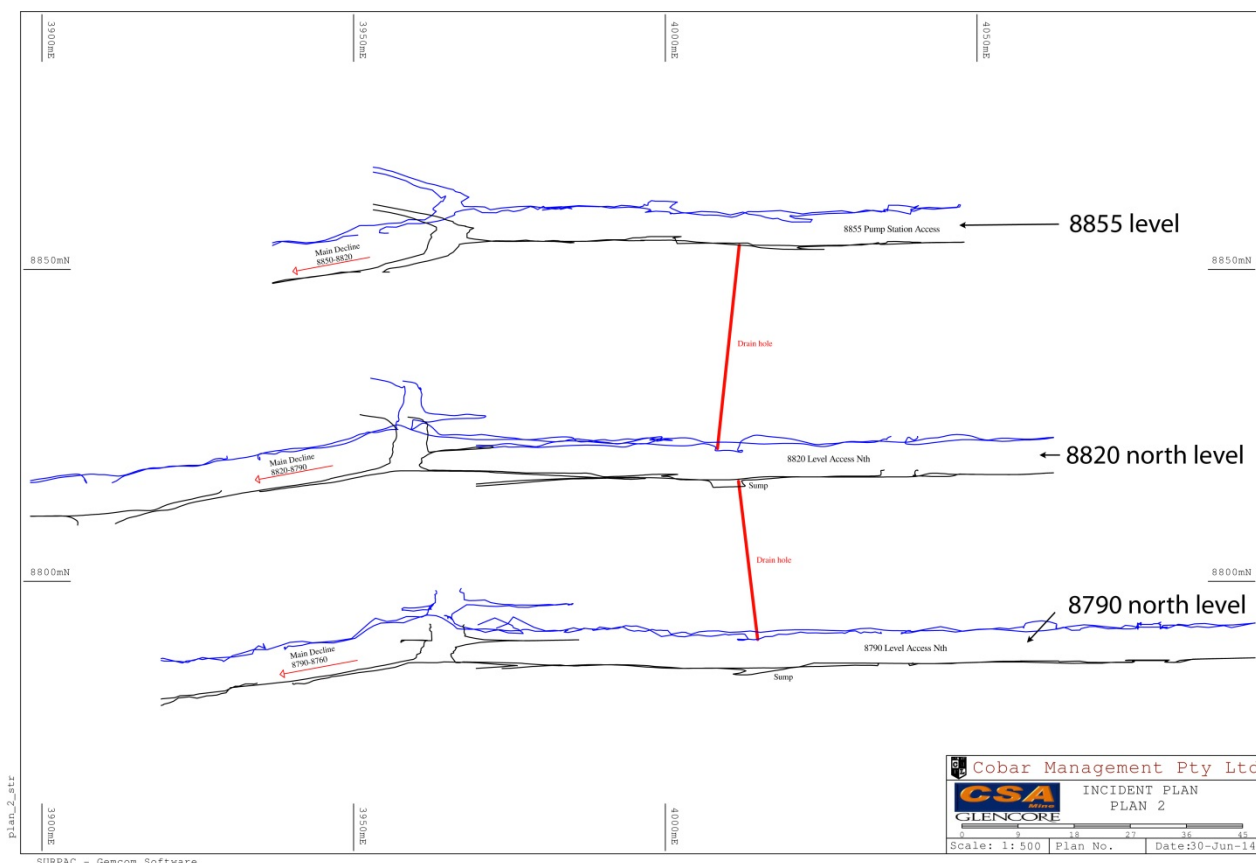
Figure 2 Incident plan 2 shows a section view of the 8820 north sump incident scene relative to the level sumps above and below.

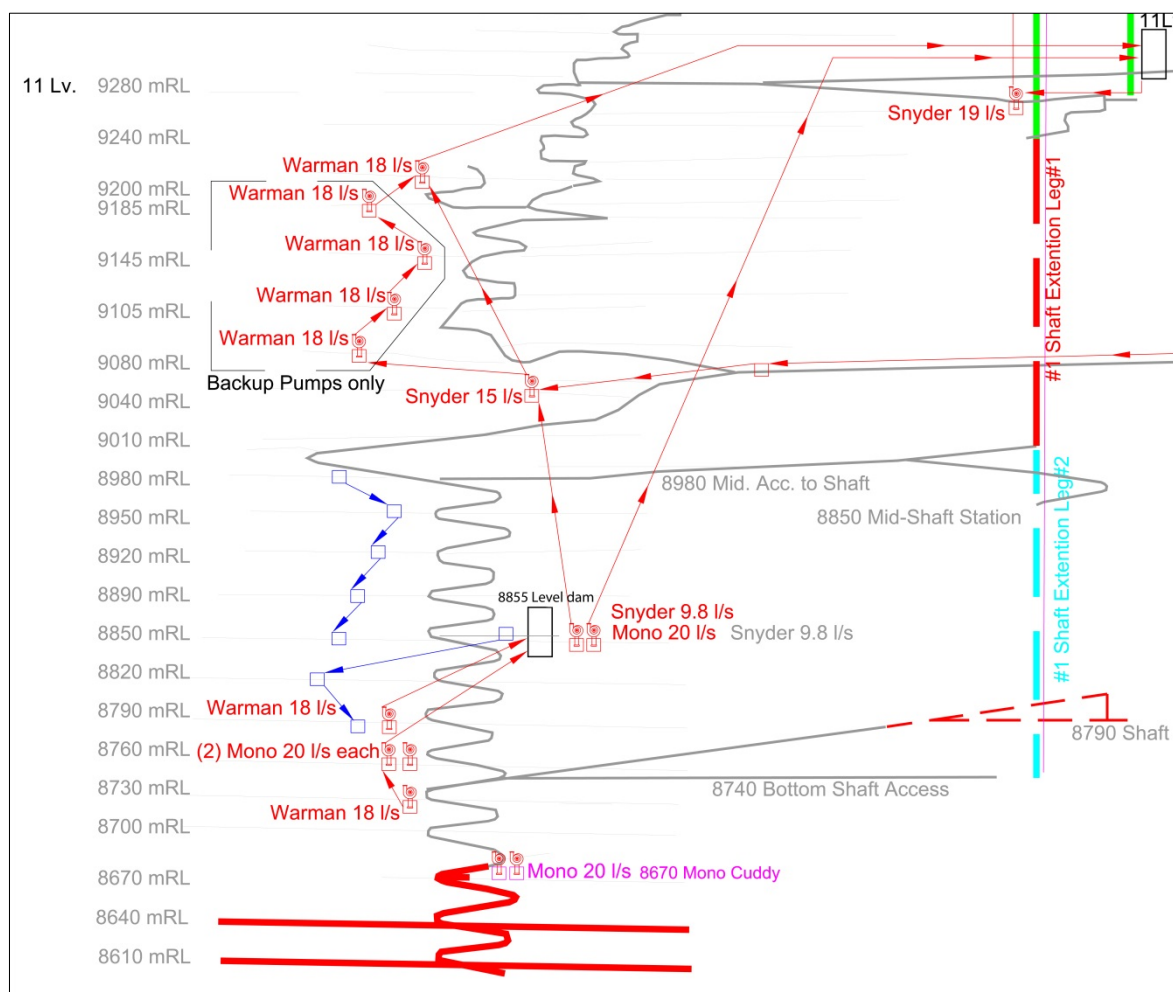
Figure 6 is a crop of a larger mine plan provided to investigators. It depicts the dewatering arrangements at the mine in the QTS North system at the time of the incident.

Before 1 June 2014, the mine dewatering system allowed over flow from the 8855 pump station to travel down a drain hole to the 8820 north sump. Drain holes are depicted as blue arrows in the figure above. The 8820 north sump drain hole reported to the 8790 sump where a Warman pump transferred water back to the 8855 pump station. Failure of the pumps at the 8855 level would mean that water would recirculate through the 8820, 8790 and 8855 levels. Water below the 8790 level would be transferred to the 8855 level through separate Warman/Mono pumping arrangements (depicted in figure 6). Water pumped from those levels would also recirculate through the 8820, 8790 and 8855 levels when the pumps at the 8855 broke down.

The water pumped throughout the mine has high solid content. Water with high solid content is known to limit pump life and impact on pump maintenance and service intervals. Water high in solids at the 8855 level was destroying the pumps at the 8855 pump station. The 8855 pumps were subject to continual break down and maintenance issues. These pump break downs caused hazardous conditions in some areas of the mine, which had led to production loss.

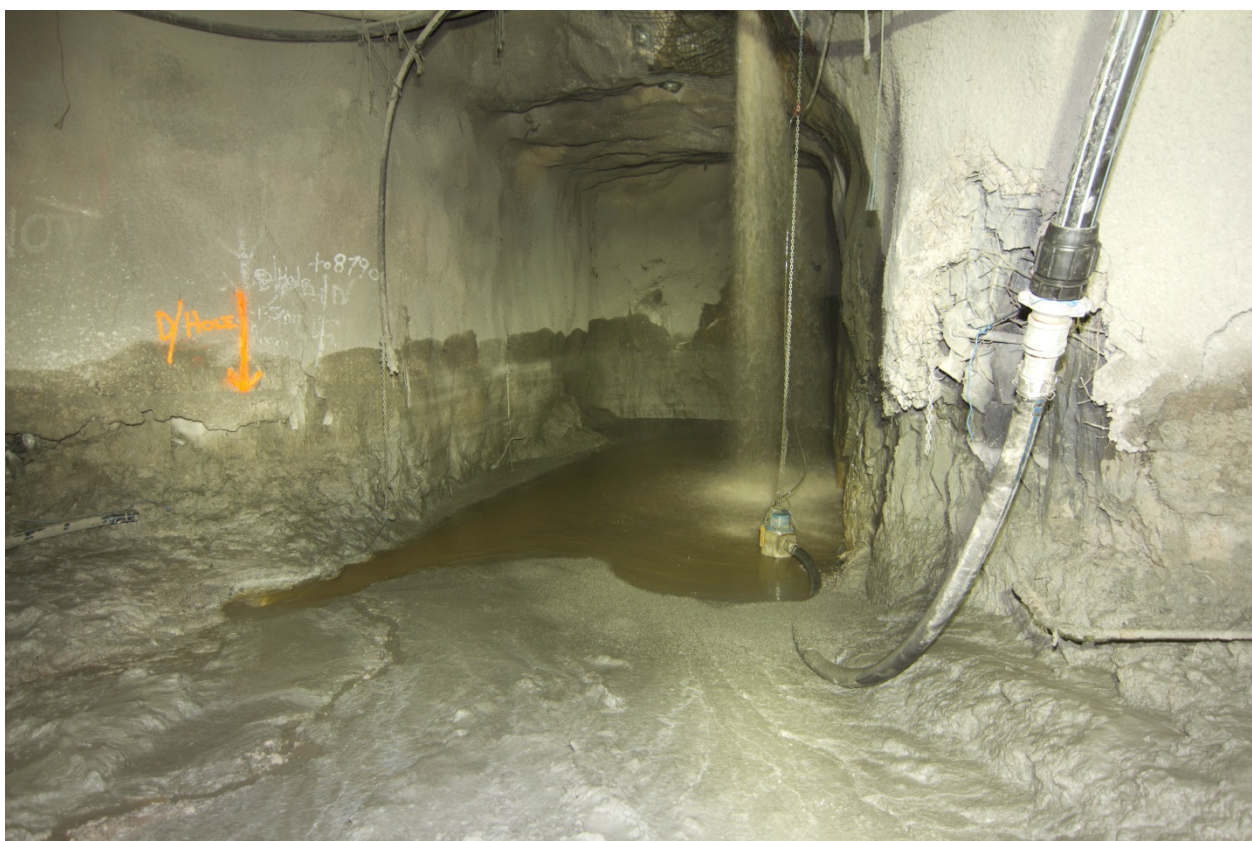
Figure 7 depicts the 8820 north sump at CSA Mine as observed by investigators on 12 June 2014. Note elevated water level has subsided due to unblocked drain hole. Photo by Mine Safety Investigation Unit

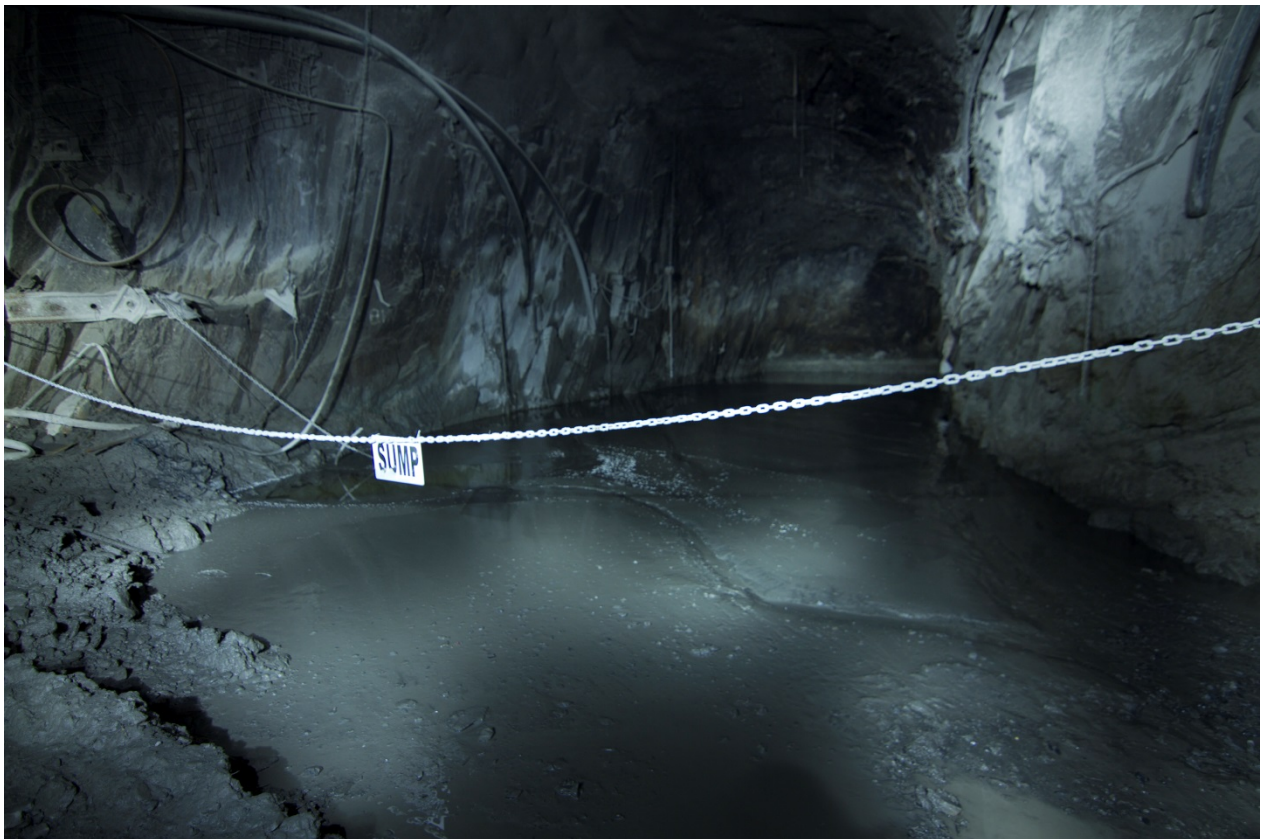
Figure 8 depicts a sump in the QTS north system above the 8855 level. This sump has an overflow drain hole and does not have a submersible pump. Water from this sump will eventually drain into the 8855 level dam where it can be pumped from the mine. Photo by Mine Safety Investigation Unit.

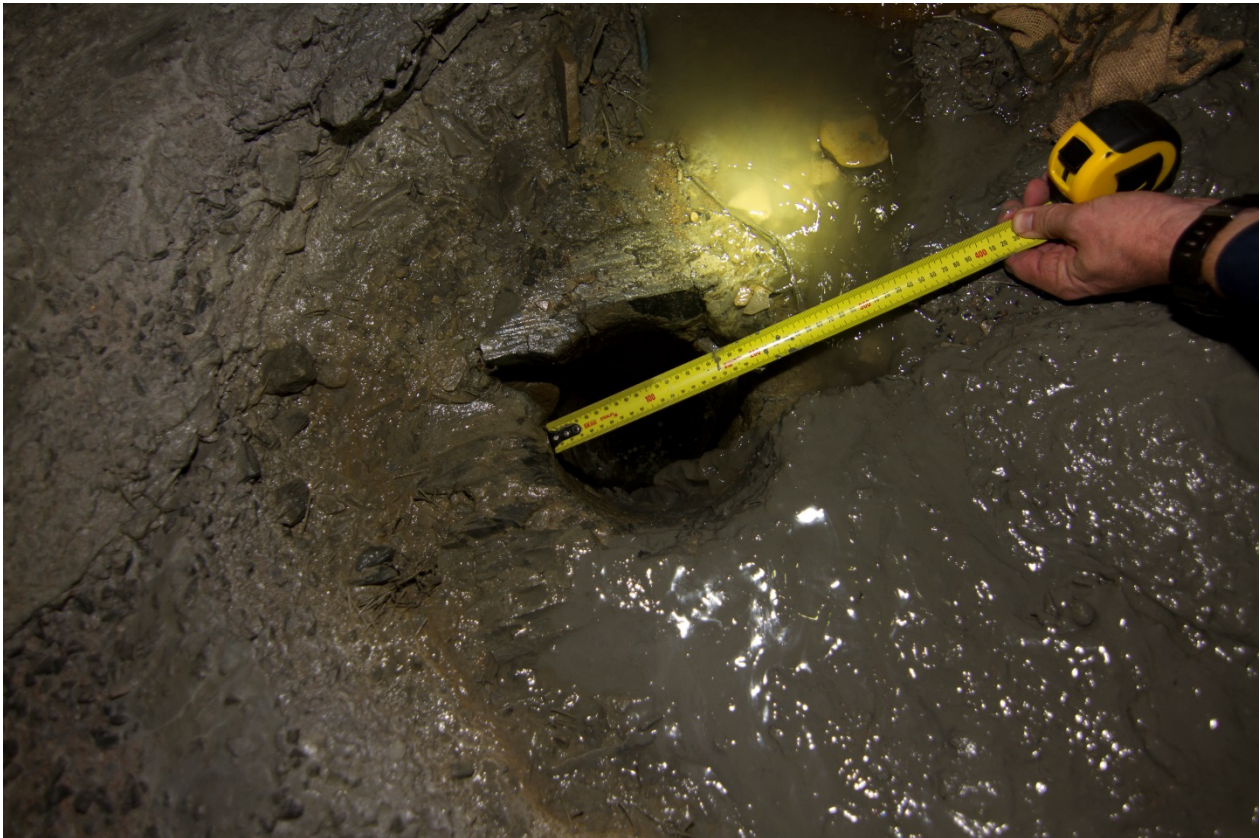
The strainer was then removed from the drain hole and leant against the mine wall. The second attempt to block the drain hole involved inflating two blast bags next to each other (in parallel). This method effectively blocked the drain hole.

Figure 9 the 8820 north sump drain hole that Mr Hern was trapped in into measures just under 200mm at the collar. The unlined drain hole reports to the 8790 sump on the level below. Photo by Mine Safety Investigation Unit.

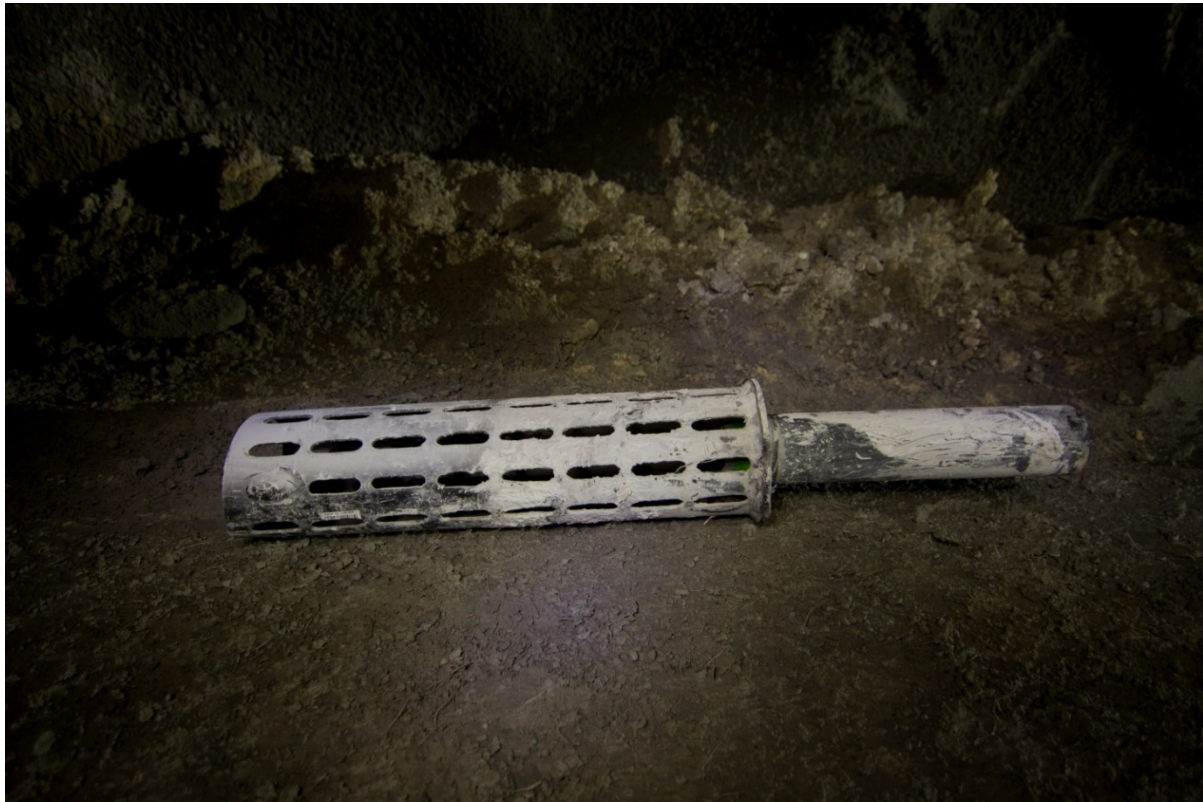
First, the service crew attempted to place one blast bag in the base of a strainer, which was positioned in the drain hole. This first attempt at blocking the hole failed as the base of the strainer was too small and did not effectively block the hole. A picture of the strainer at the scene is depicted in figure 10. Investigators observed that the base of the strainer was blocked with what is now known to be a blast bag, this is identified in figure 11.

Figure 10 Investigators found this strainer at the high water level mark of the 8820 north sump at the far end of the access roadway. Investigators observed a blockage in the solid pipe end that appeared to be a blast bag. Photo by Mine Safety Investigation Unit

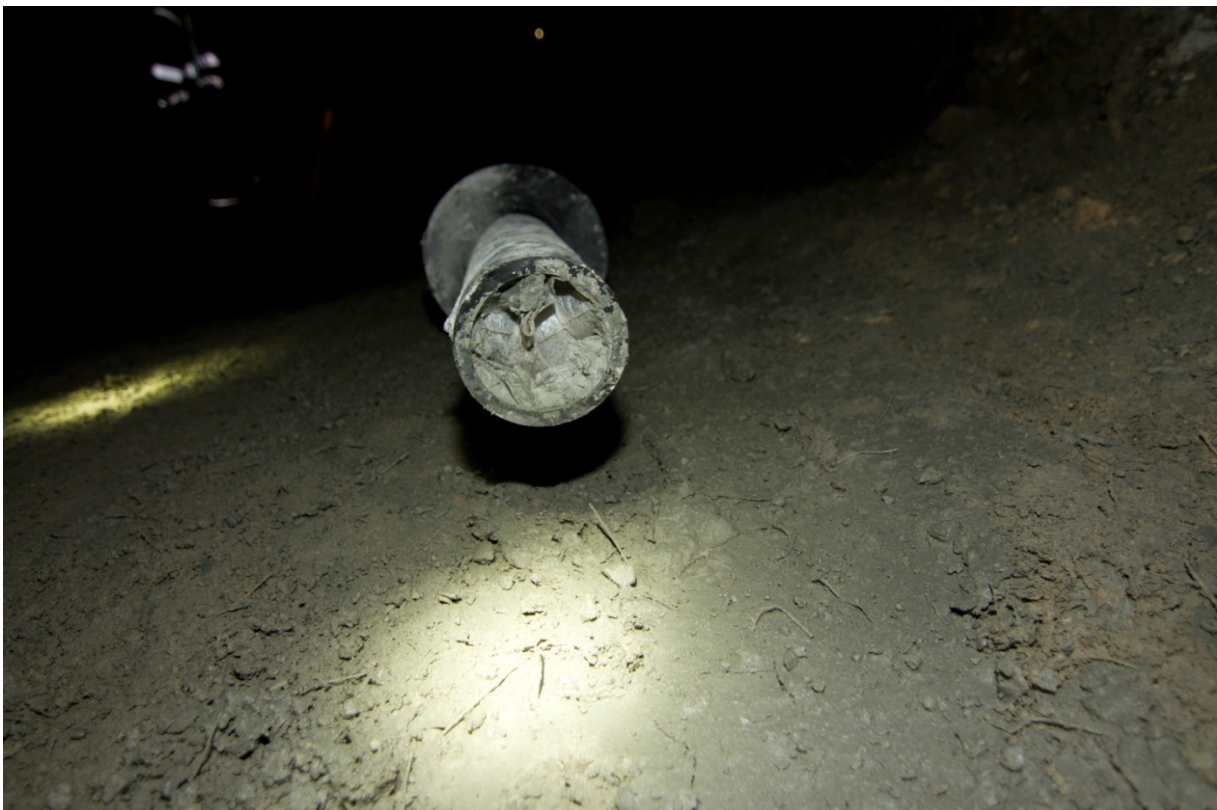
Figure 11 shows the blast bag in the base of the strainer at the 8820 north level sump scene. Photo by Mine Safety Investigation Unit

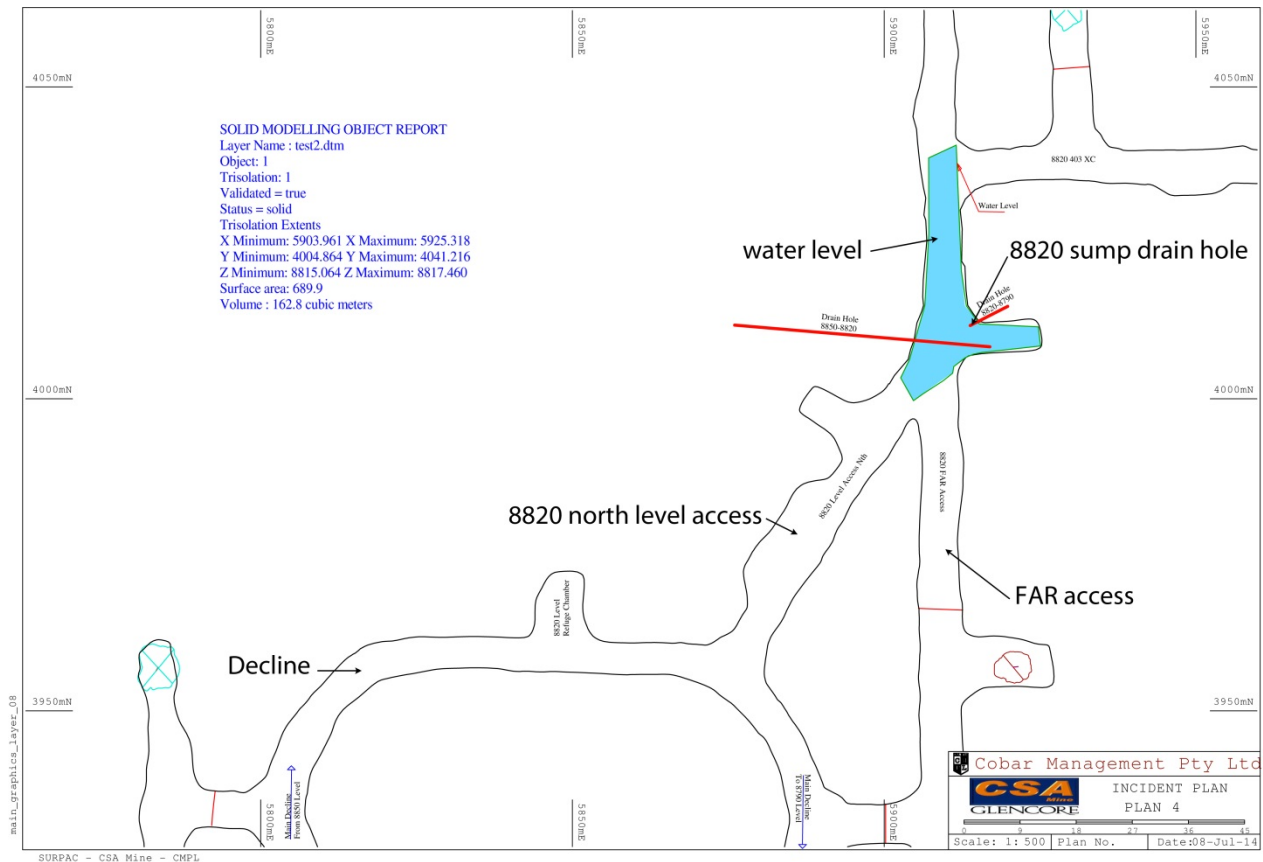
At this time water was about 1.43m deep at the drain hole with approximately 162800 litres filling the sump and adjacent roadways. The plan below (figure 12) depicts the 8820 north level access with the water level marked in blue.

Figure 12 shows the 8820 north level access including the 8820 north sump and the water level at the time of the incident. Water level is an approximation based on corroborating eyewitness accounts. It is noted that one of the drain holes depicted states it is from the 8850 level to the 8820. Investigators believe that this is incorrect and in fact the drain hole was from the 8855 level to the 8820 level. This has been confirmed with corroborating evidence from other plans and individuals.

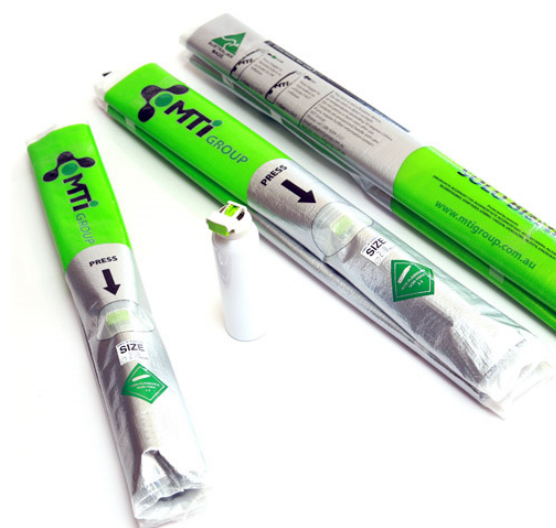
MTi do not manufacture a product which has been designed for the purpose of plugging any size drain hole which can be remotely activated and deactivated.

Figure 13 a product shot of the MTi SOLO blast bag. Evidence suggests that two 115mm diameter versions of this product were used to block the 8820 north sump drain hole by inflating them in parallel in the top of the drain hole. Photo courtesy of MTi

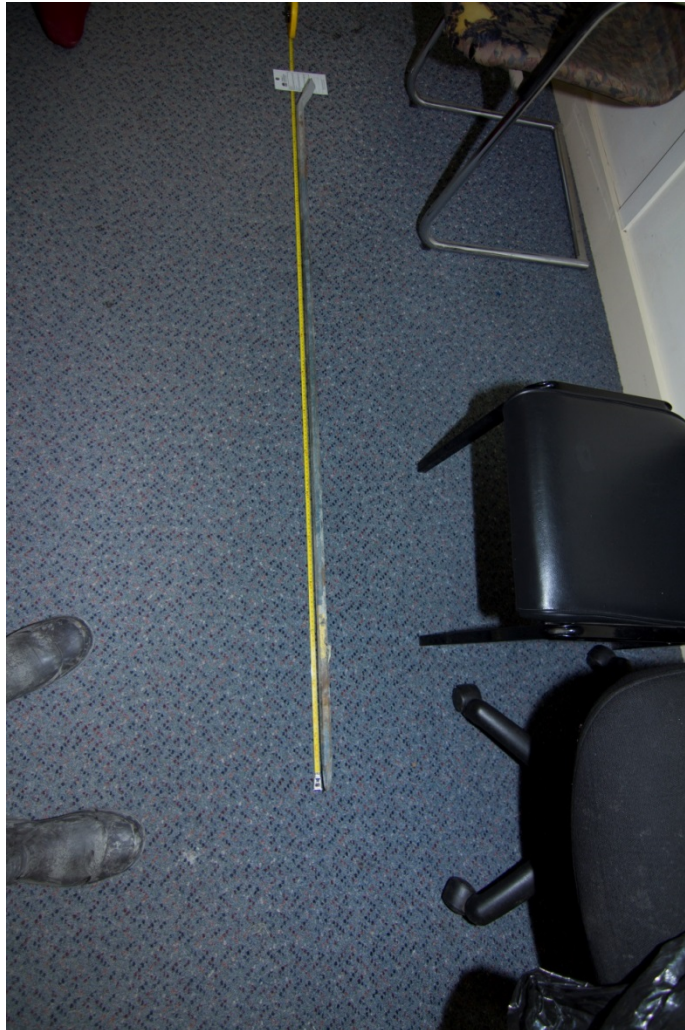
In a response from the manufacturer of the stope blast bags, it was highlighted that there was risk of the aerosol canister inside the bag exploding if the bag was lanced incorrectly. As Mr Hern had no way of knowing exactly where the bags were located (or exactly what was blocking the drain). The use of a sharp spear like object (such as a scaling bar) to burst the bags exposed

Figure 14 is a picture of a scaling bar seized by NSW Police after it was retrieved by CSA mine staff at the 8790 level collar of the 8820-8790 drain hole. It is believed that this may be the scaling bar that was used in the attempted unblocking of the 8820 north sump drain hole. Photo by Mine Safety Investigation Unit

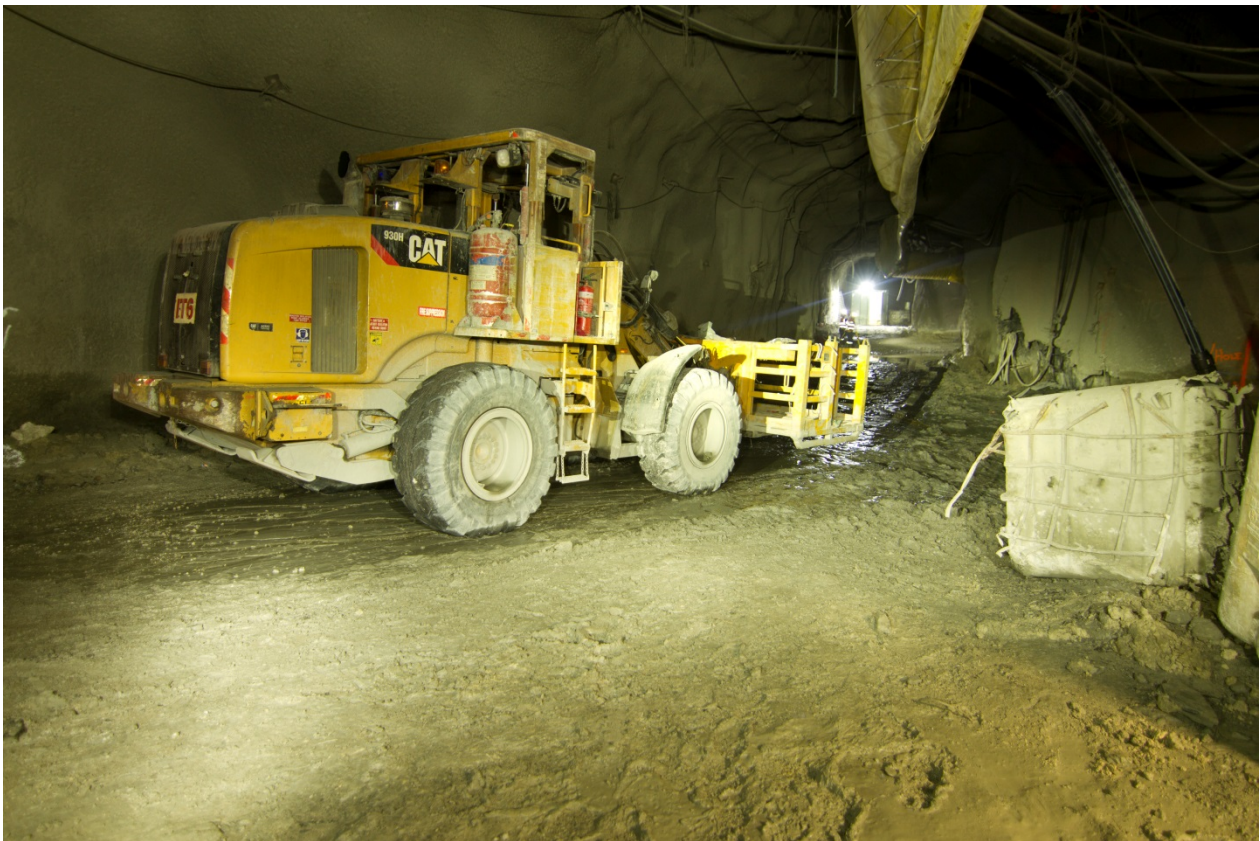
An Integrated Tool Carrier (IT6) was used by Mr Hern's co-worker to transport Mr Hern into the sump for the purpose of unblocking the drain hole. IT6 was equipped with a man riding basket attached to the front of the machine. IT6 was also used in the subsequent recovery of Mr Hern from the sump. A full functionality test was undertaken on IT6 following the incident by the mine. There were no performance issues with IT6 that would have contributed to this incident.

Figure 15 IT6 is the integrated tool carrier that was used to transport Mr Hern into the over flowing 8820 north sump. It was also used in the recovery. Photo by Mine Safety Investigation Unit

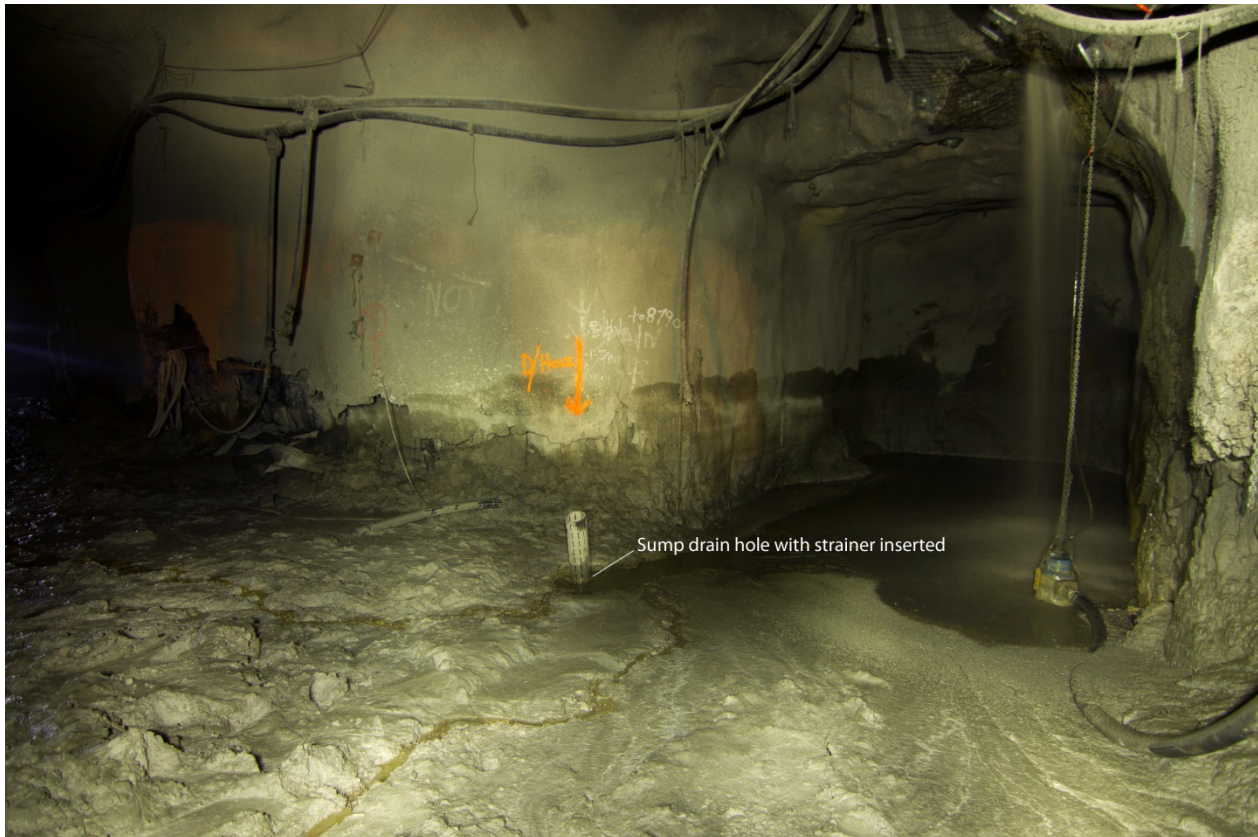
Figure 17 shows the 8820 north sump scene on 13 June 2014. Note the strainer in the drain hole provides two purposes. 1. To prevent the hole blocking and 2. As guarding to prevent access to the drain hole. Photo by Mine Safety Investigation Unit

Another engineering solution identified is appropriate guarding around the drain hole. The strainer that was in the hole before the incident constituted a guard that would have reduced the risk of Mr Hern becoming stuck in the drain hole. Further, a steel mesh grate installed over the drain hole would have been an effective hard barrier.
